Defect No. 202. Chip in Glass. Minor defect. An area where glass has been broken off, but does not materially weaken the bottom of the body wall.

Defect No. 203.
Stone in glass. Minor
defect. Unmelted
opaque material
imbedded in the glass.

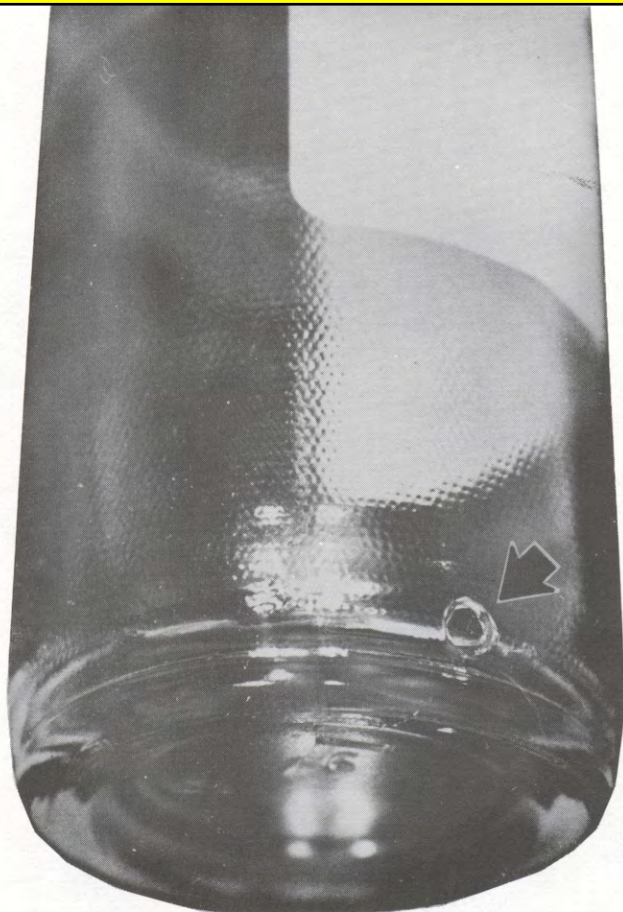
Defect No. 102. Bead. Major Defect. A bubble in the body wall exceeding 1/8 inch in diameter that weakens the body wall.

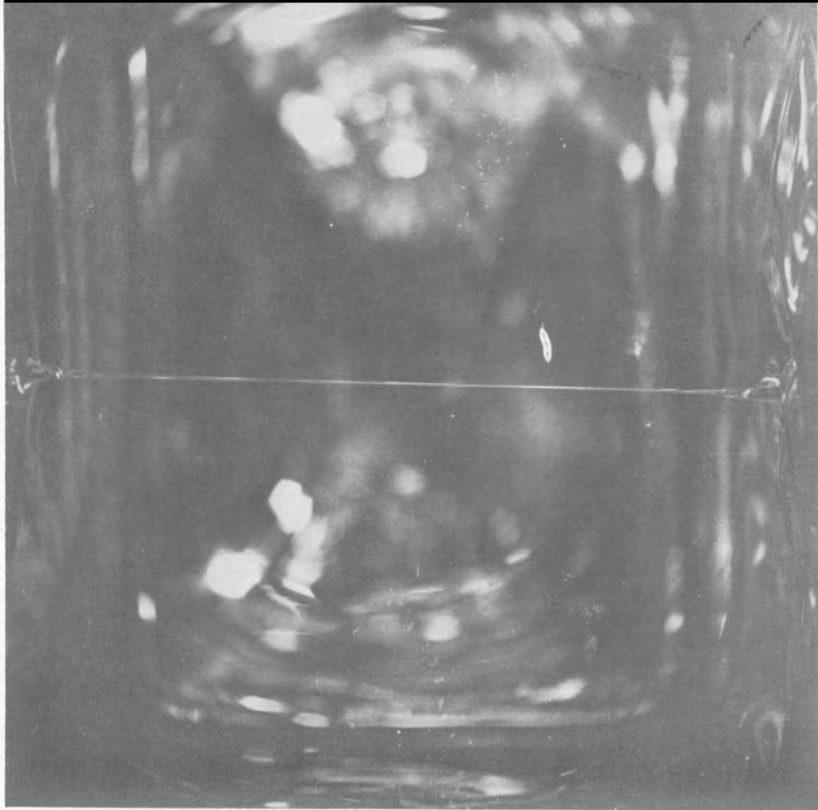
Defect No. 1. Bird Swing. Critical defect. A cordlike glass appendage inside container as viewed through the open neck of the bottle. Difficult to observe in filled container but could result in glass contamination of product.
